Re: Variance Request – Eaton Sugar Beat Factory (Work Area 3A), CO Section III.W.

Regulation No. 8, Part B Variance Request Form

Subject: **Eaton Sugar Beet Factory, Structural Recommendations No. 2**

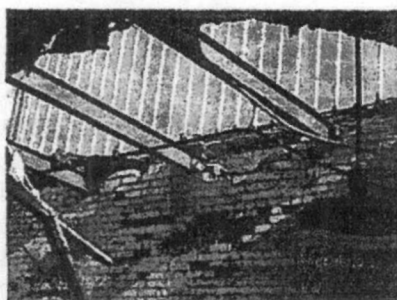
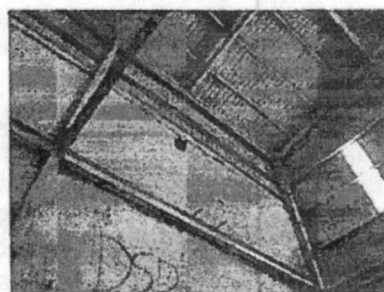
Zone 3a, adjacent to Zone 2, was observed due to concern about the roof structure and its supporting masonry wall. The wall in question is at the south end of Zone 3a, and abuts the metal building framing of Zone 2. As shown in the photograph below, this load bearing wall is supporting the steel beams which support the concrete roof deck.

Zone 3a is very unstable and should be considered structurally unsound. Implementation of abatement work may endanger personnel who will be removing asbestos from the facility. Additional load and vibrations on or near this wall may result in collapse of the wall which is already partially collapsed and leaning into Zone 2. Temporary shoring should be located under each steel roof beam, and continued below the floor to the slab on grade in Zone 3 below, before any work is done in this area. Care should be taken when working in this area to ensure that personnel are in Zones 2 and Zone 3 are not injured should the wall collapses and drop bricks below.

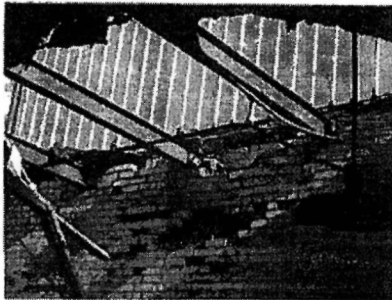
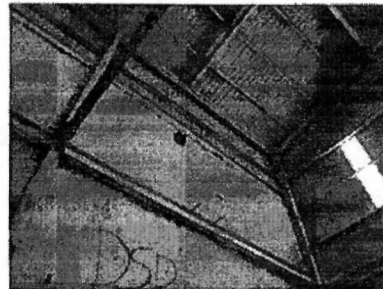
Zone 3a, adjacent to Zone 2, was observed due to concern about the roof structure and its supporting masonry wall. The wall in question is at the south end of Zone 3a, and abuts the metal building framing of Zone 2. As shown in the photograph below, this load bearing wall is supporting the steel beams which support the concrete roof deck.

Zone 3a is very unstable and should be considered structurally unsound. Implementation of abatement work may endanger personnel who will be removing asbestos from the facility. Additional load and vibrations on or near this wall may result in collapse of the wall which is already partially collapsed and leaning into Zone 2. Temporary shoring should be located under each steel roof beam, and continued below the floor to the slab on grade in Zone 3 below, before any work is done in this area. Care should be taken when working in this area to ensure that personnel are in Zones 2 and Zone 3 are not injured should the wall collapses and drop bricks below.

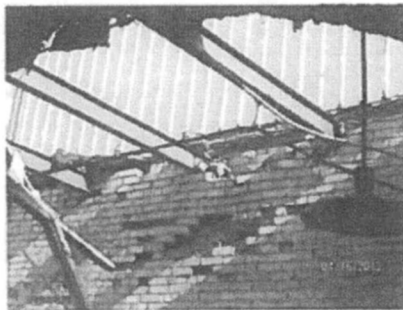
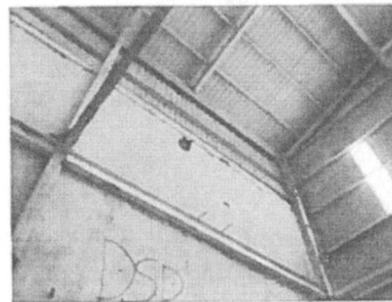
Zone 3a, adjacent to Zone 2, was observed due to concern about the roof structure and its supporting masonry wall. The wall in question is at the south end of Zone 3a, and abuts the metal building framing of Zone 2. As shown in the photograph below, this load bearing wall is supporting the steel beams which support the concrete roof deck.

Zone 3a is very unstable and should be considered structurally unsound. Implementation of abatement work may endanger personnel who will be removing asbestos from the facility. Additional load and vibrations on or near this wall may result in collapse of the wall which is already partially collapsed and leaning into Zone 2. Temporary shoring should be located under each steel roof beam, and continued below the floor to the slab on grade in Zone 3 below, before any work is done in this area. Care should be taken when working in this area to ensure that personnel are in Zones 2 and Zone 3 are not injured should the wall collapses and drop bricks below.

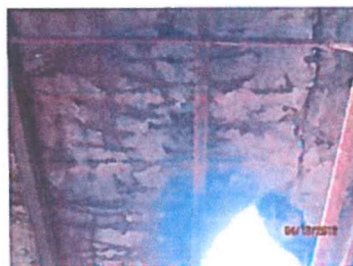
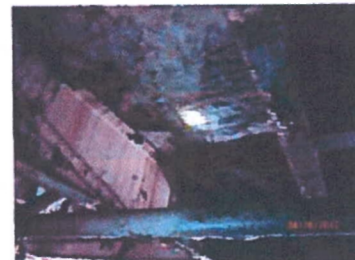
The deterioration observed throughout the floors of the Main Mill Building typically consisted of deteriorated concrete and exposed, corroded steel wire reinforcing. This deterioration is likely due to continued exposure to moisture which corroded the steel and damaged/delaminated the concrete cover on the underside of the slabs. This type of deterioration has an impact on the slabs structural capacity, specifically with regard to resisting punching shear from large point loads applied over a small area. Evidence of this can be seen in the photographs below and is the main reason it is not recommended to use the electric pallet jack on these floors.

Do not use motorized electric pallet jack on floors with exposed reinforcing. Floor areas with exposed wire reinforcing, or those suspected of having corroded reinforcing, should be accessed with caution and if concentrated point loads in excess of foot traffic are expected, supplemental measure should be taken. These measures need to provide some level of "redundancy" or "support" to keep something from creating or falling through a hole in the concrete slabs and could consist of sheets of plywood or expanded wire mesh panels spanning over the steel support beams below.

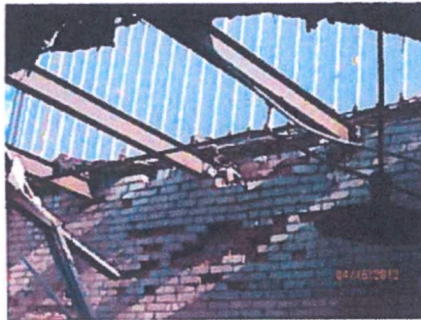
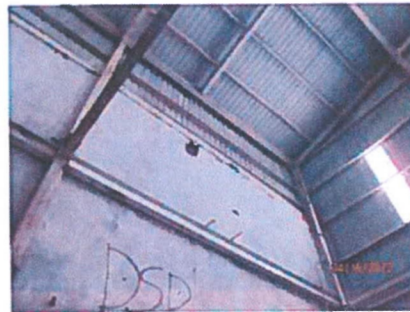
Zone 3a, adjacent to Zone 2, was observed due to concern about the roof structure and its supporting masonry wall. The wall in question is at the south end of Zone 3a, and abuts the metal building framing of Zone 2. As shown in the photograph below, this load bearing wall is supporting the steel beams which support the concrete roof deck.

Zone 3a is very unstable and should be considered structurally unsound. Implementation of abatement work may endanger personnel who will be removing asbestos from the facility. Additional load and vibrations on or near this wall may result in collapse of the wall which is already partially collapsed and leaning into Zone 2. Temporary shoring should be located under each steel roof beam, and continued below the floor to the slab on grade in Zone 3 below, before any work is done in this area. Care should be taken when working in this area to ensure that personnel are in Zones 2 and Zone 3 are not injured should the wall collapses and drop bricks below.

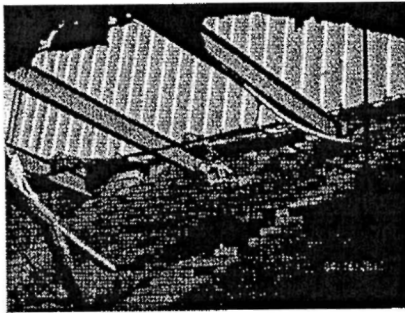
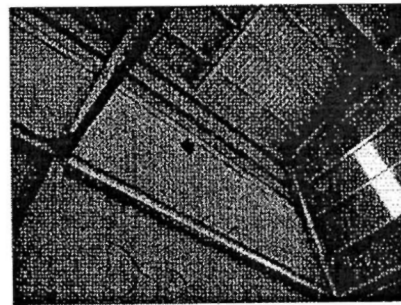
~~Zone 3a of the Kiln Building, adjacent to Zone 2 of the East Metal-Sided Boiler Building,~~ ^{Remove} was observed due to concern about the roof structure and its supporting masonry wall. The wall in question is at the south end of Zone 3a, and abuts the metal building framing of Zone 2. As shown in the photograph below, this load bearing wall is supporting the steel beams which support the concrete roof deck. ^{Remove}

Zone 3a is very unstable and should be considered structurally unsound. Implementation of abatement work may endanger personnel who will be removing asbestos from the facility. Additional load and vibrations on or near this wall may result in collapse of the wall which is already partially collapsed and leaning into Zone 2. Temporary shoring should be located under each steel roof beam, and continued below the floor to the slab on grade in Zone 3 below, before any work is done in this area. Care should be taken when working in this area to ensure that personnel are in Zones 2 and Zone 3 are not injured should the wall collapses and drop bricks below.
